MERRIMACK RIVER BASIN  
DUNSTABLE, MASSACHUSETTS

MASSAPOAG POND DAM  
MA 00136

PHASE I INSPECTION REPORT  
NATIONAL DAM INSPECTION PROGRAM

NOVEMBER 1978

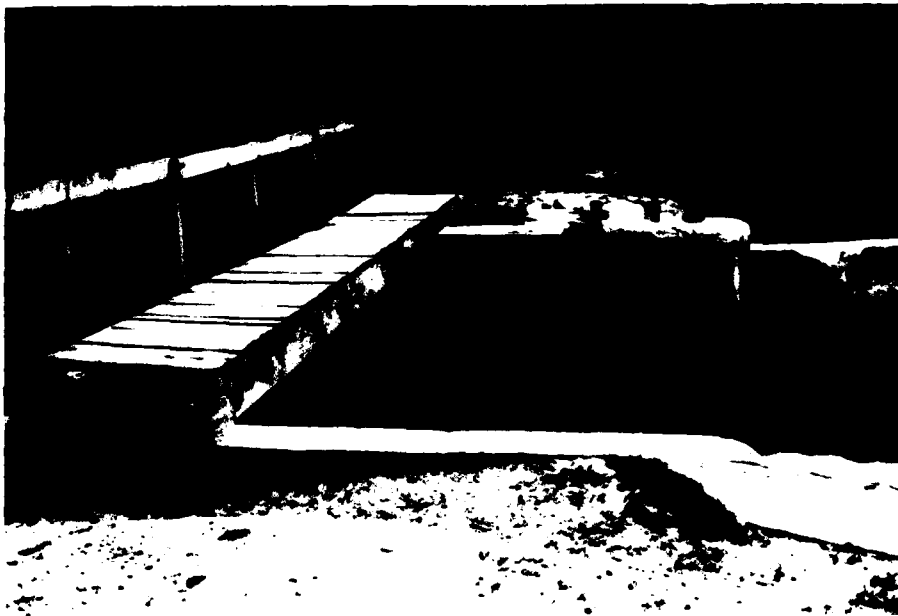
- The footbridge over the weir is in fair condition. A few of the deck planks are missing and the ends of the timber stringers have started to deteriorate as shown in Photo Nos. 8 and 9. The foot bridge and the operator platform require replacement of individual members and painting.

9. RESERVOIR DRAIN GATE OPERATOR AND FOOTBRIDGE FROM  
LEFT ABUTMENT.

4. Replace the deteriorated members in the operating platform and footbridge.
5. Paint all exposed timber members to minimize future deterioration.
6. Remove all minor vegetation from concrete surfaces and remove all deteriorated concrete. Local spalled and eroded areas should be patched.
